HACKENSACK RIVER BASIN
PASCACK BROOK, BERGEN COUNTY
NEW JERSEY

ELECTRIC LIGHT
POND DAM
NJ 00245 S

PHASE 1 INSPECTION REPORT
NATIONAL DAM SAFETY PROGRAM

FEBRUARY 1980

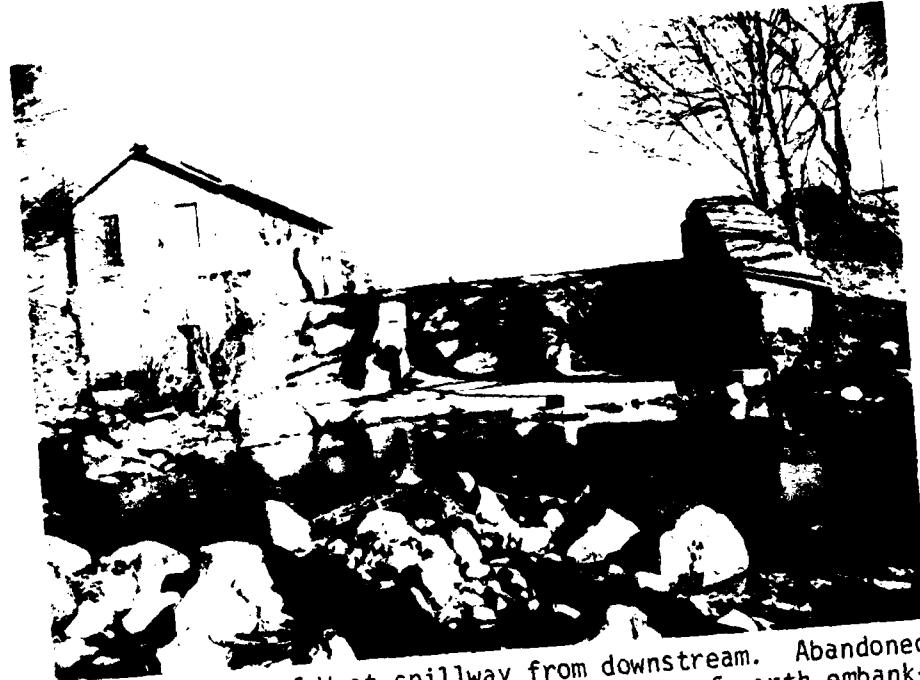
Photo 1 - View of West spillway from downstream. Abandoned power house is at left. Portion of earth embankment is at right.

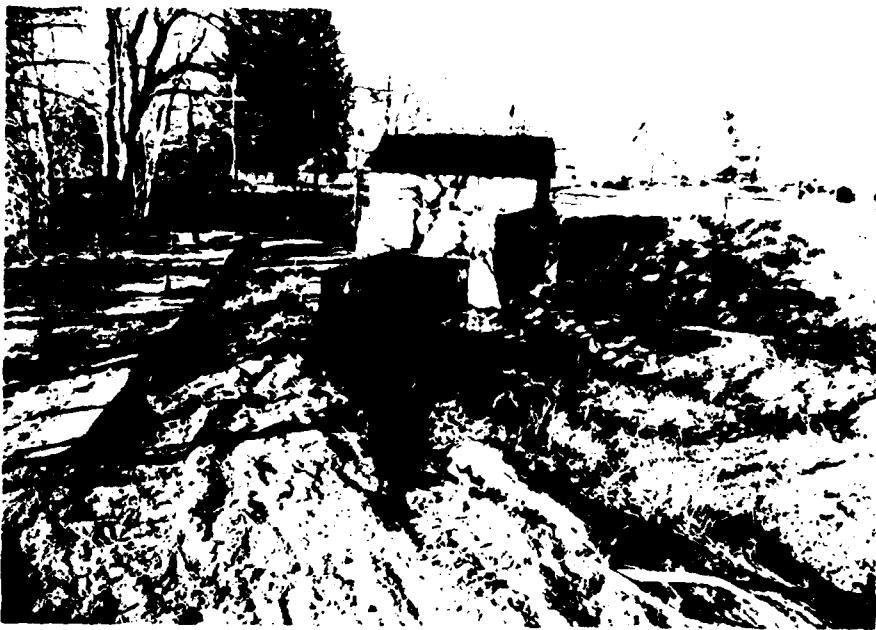
Photo 3 - View from reservoir side with dam and concrete core visible at left. The West spillway, adjacent to the abandoned power house, can be seen in center.

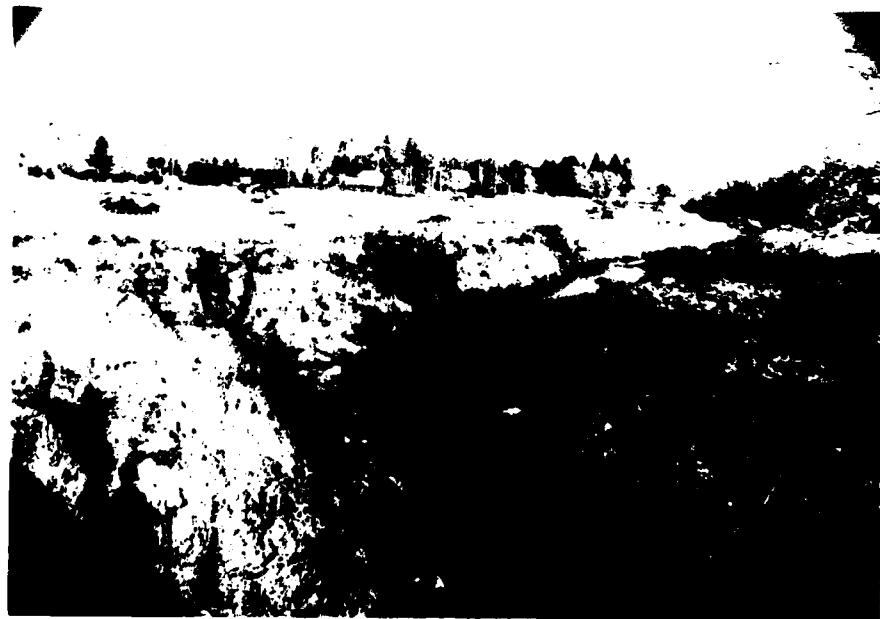
Photo 8 - View of reservoir from East spillway showing current
dredging operations.

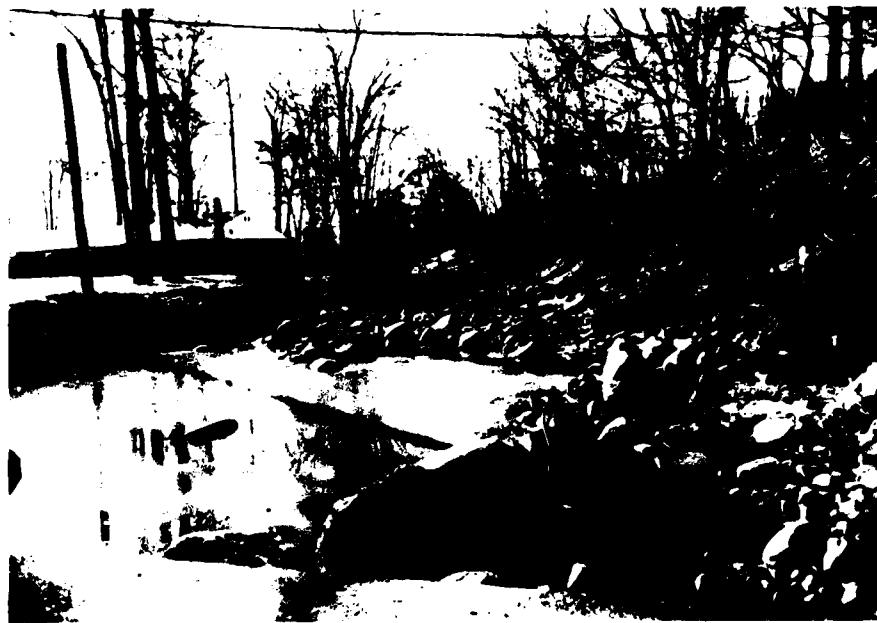
Photo 11 - View of downstream channel from West spillway
(at bottom).

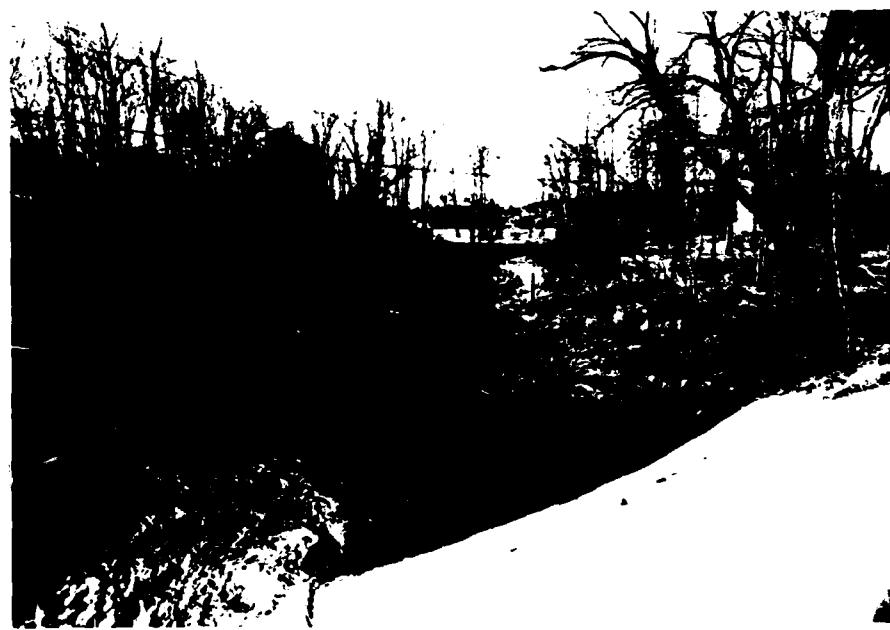
Photo 12 - View of East downstream channel. Sluice way water from under East spillway is shown at left and portion of emergency spillway at right.
